Our Ref: 17007.SI170703a 69 Kissing Point Rd- Structural Inspection

69 KISSING POINT ROAD, TURRAMURRA: SITE INSPECTION 7TH JULY 2017

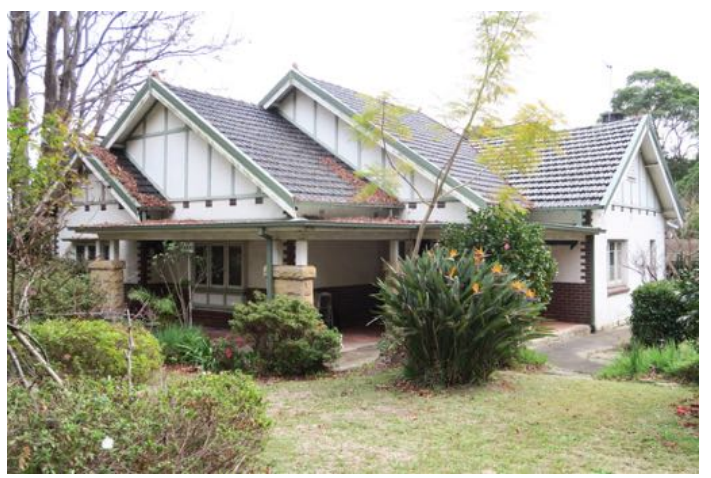
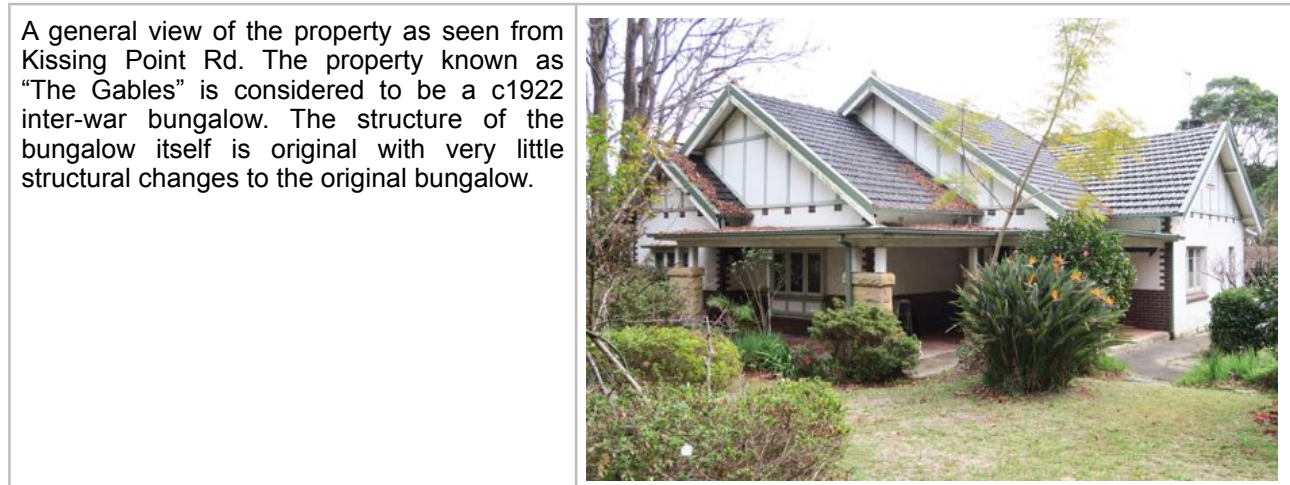
2.1.

A general view of the property as seen from Kissing Point Rd. The property known as "The Gables" is considered to be a c1922 inter-war bungalow. The structure of the bungalow itself is original with very little structural changes to the original bungalow.

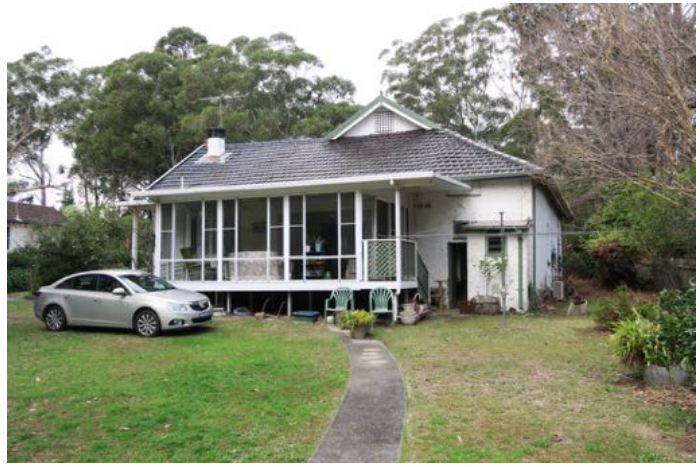
2.1.1.

A general view of the exterior of the property from the rear.

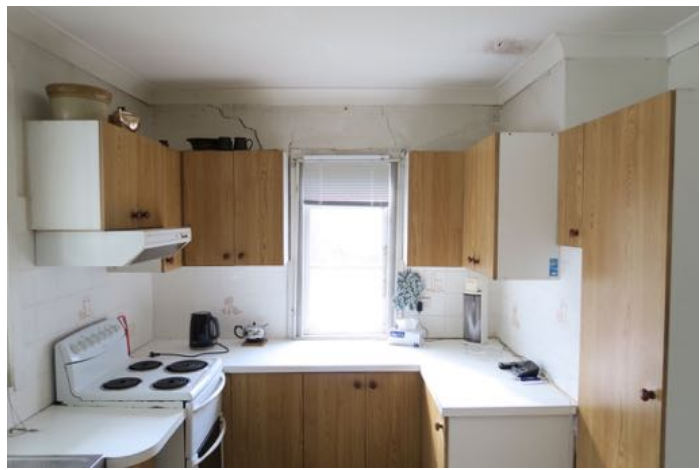
IMG_1449
Cracking is visible on the interior skin of brick work, above the exterior window.

4.2. Following remediation of the storm water system, the existing cracks in the property can be stitched.

These cracks are to be structurally stitched with a helical reinforcement system such as Helifix or similar, to manufacturers specification. This should occur minimum six months after the down pipes have been connected.

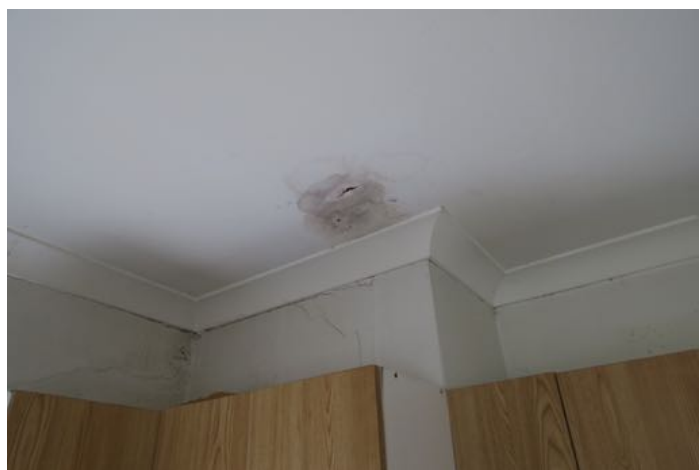
2.2.1.

IMG_1450
Water damage is visible on the ceiling. It is not apparent if the water is currently entering this location or if the damage has occurred in the past, and since been rectified.

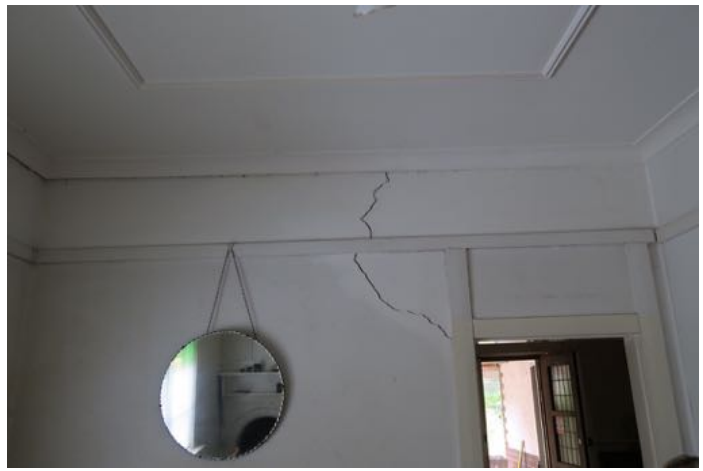
IMG_1452

Cracking is present on the internal southern wall.

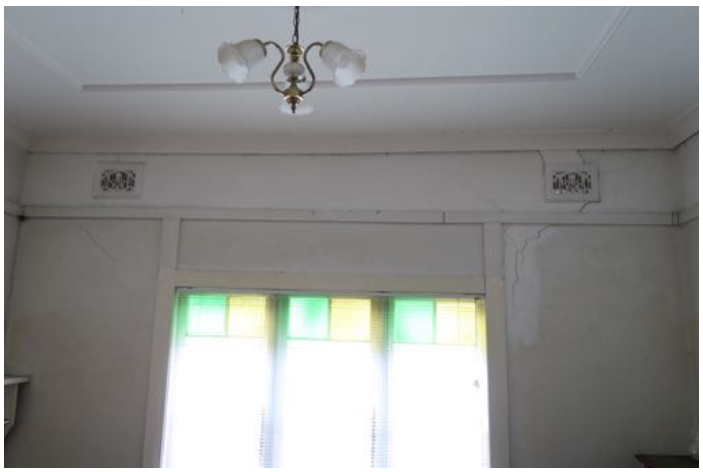
IMG_1453

Cracking is present above the window on the western wall.

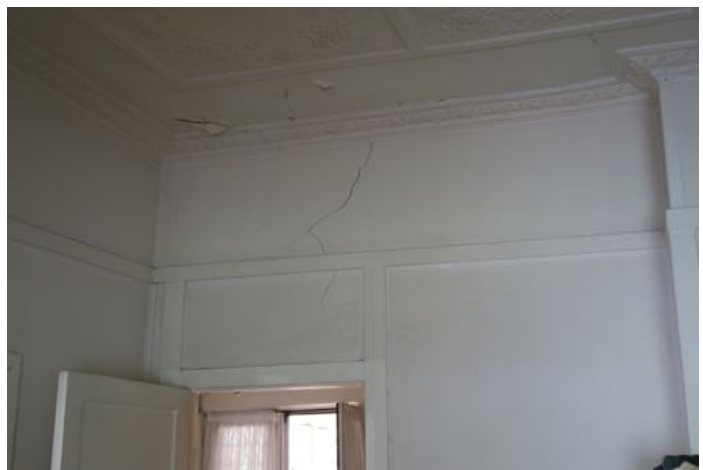
IMG_1456

Cracking is present above the doorway in the southern wall.

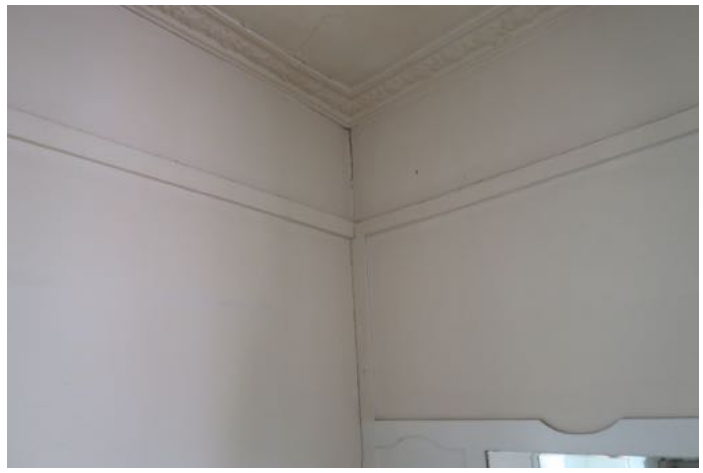
IMG_1457

The junction between the rear addition and the original wall is showing some signs of minor movement.

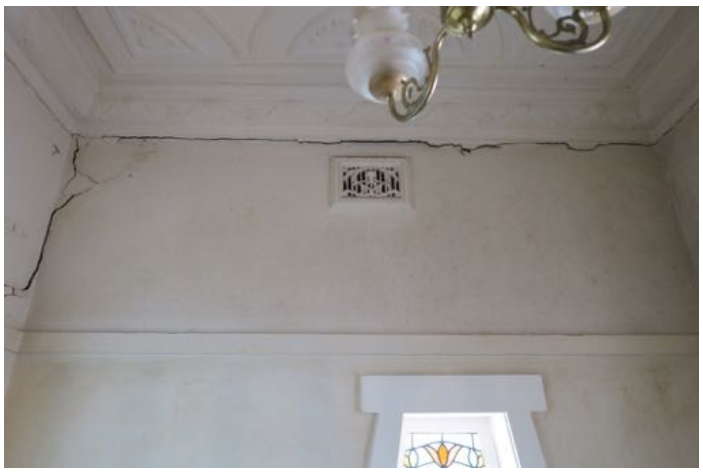
IMG_1458

Cracking is present on the western wall in the entry way.

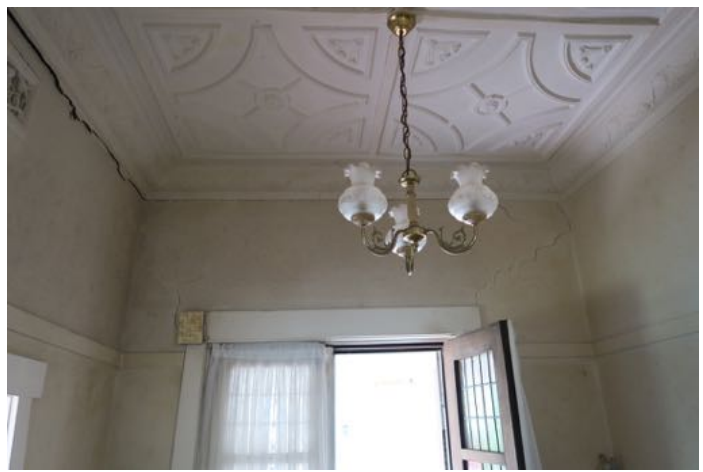
IMG_1459

Cracking is present above the main entry doorway.

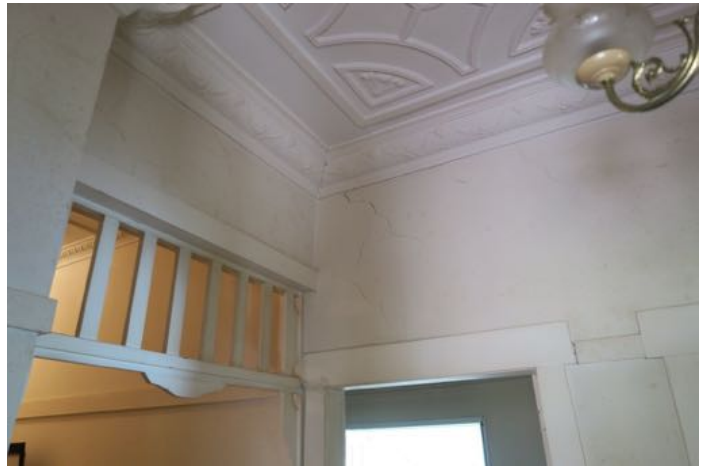
IMG_1460

Cracking seen from the other side of the wall as seen in image IMG_1456

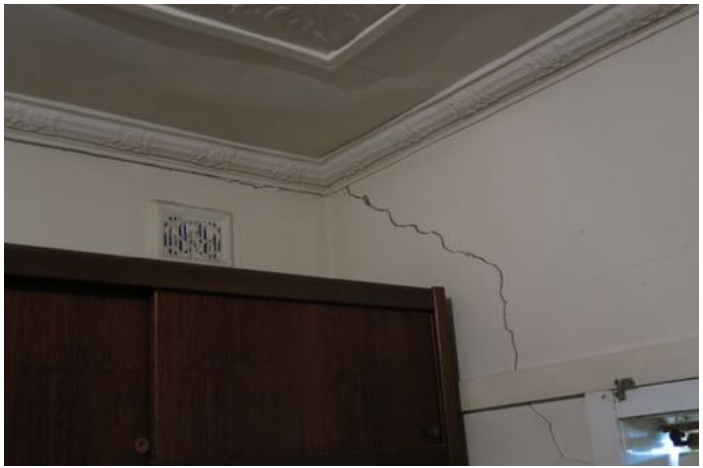
IMG_1463

Cracking on the southern wall adjacent to the window.

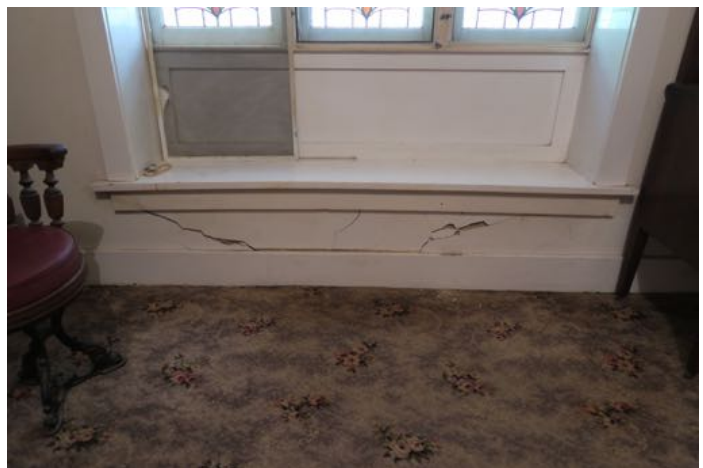
IMG_1464

Base of the bay window shows cracking.

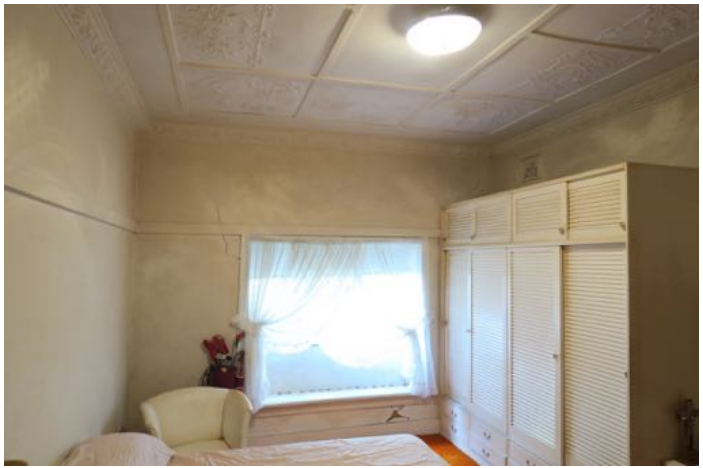
IMG_1470

Cracking is present on the upper corners of the window and below the window, similar to the main bedroom.

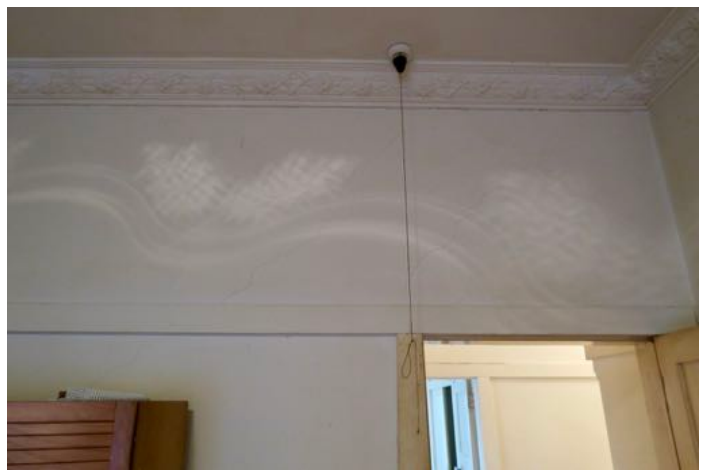
IMG_1473

Cracking seen from the internal wall as seen in IMG_1469

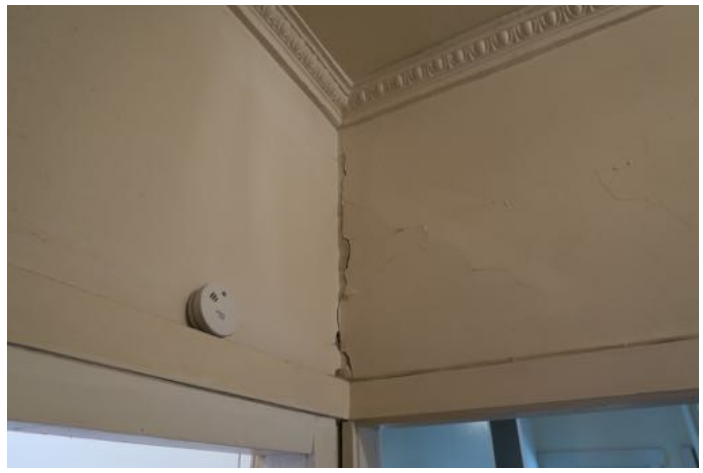
IMG_1474

Cracking present at the junction of the bathroom wall/ hallway and bedroom three.

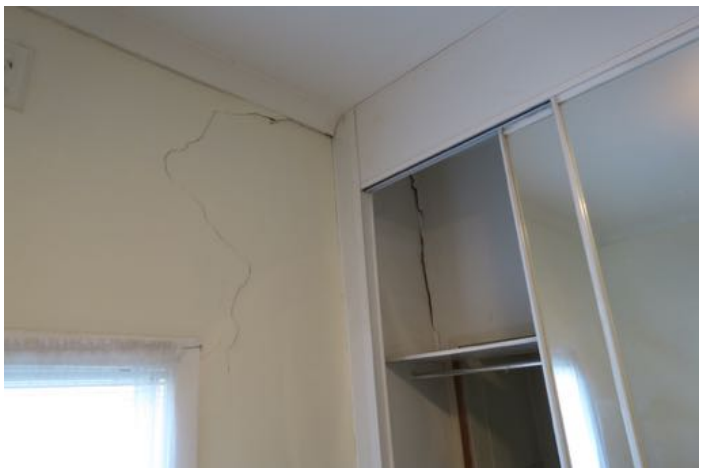
IMG_1476

Cracking present in the western exterior wall. The wall in this location is showing significant bowing in the wall.

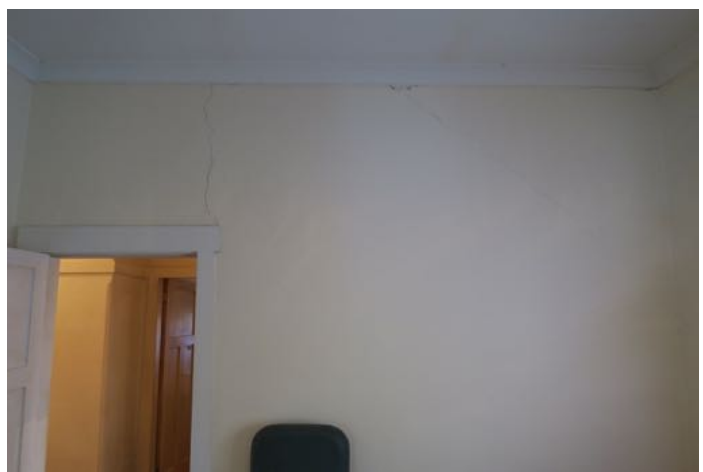
IMG_1477

Cracking present in the wall between Bedroom Three and the bathroom.

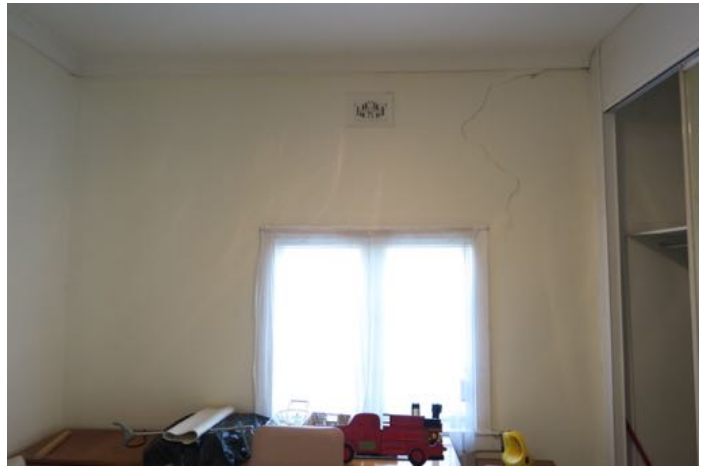
IMG_1478
Cracking present in the western wall.

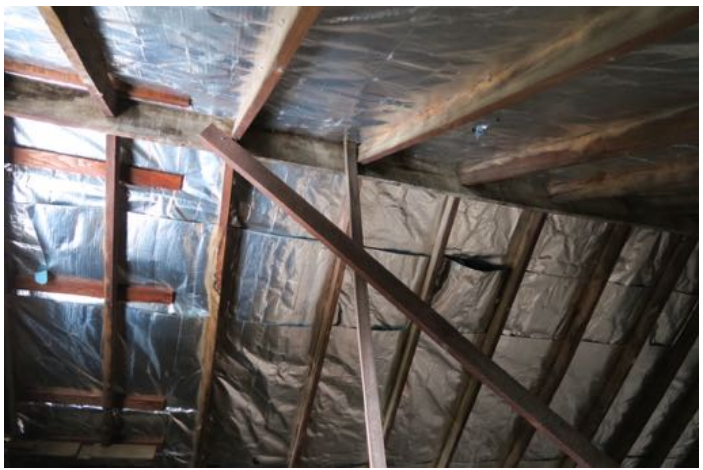
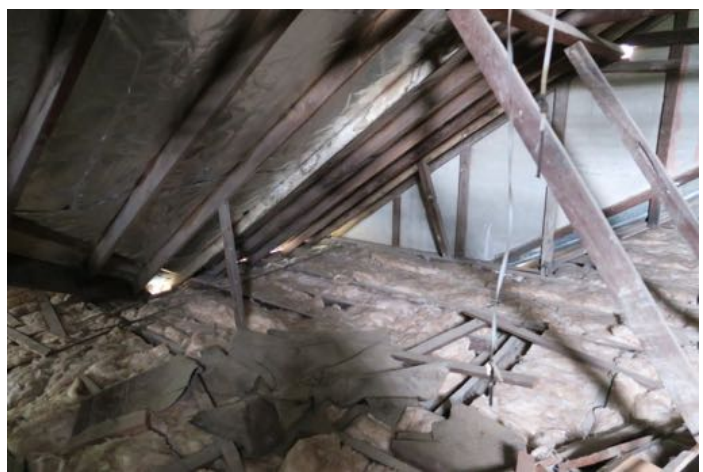
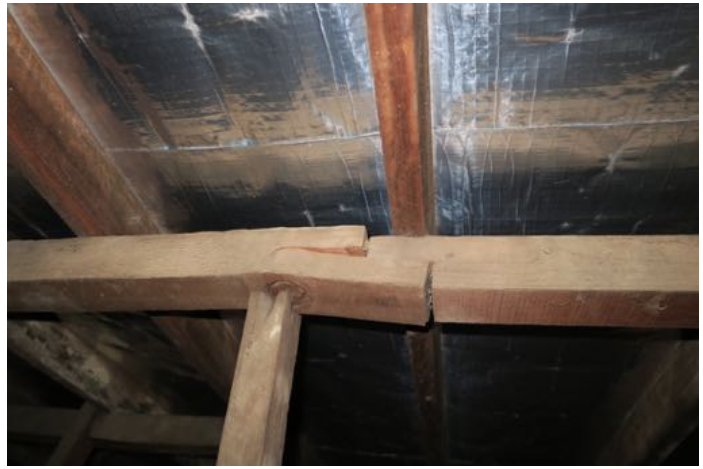
3.3. There are some roof framing members which require remediation, these members have possibly been damaged when the roof geometry was modified when the rear living area was constructed. The damaged members are limited to improperly installed roof struts and a structurally compromised roof purlin.

4.5. The roof framing is to be repaired.

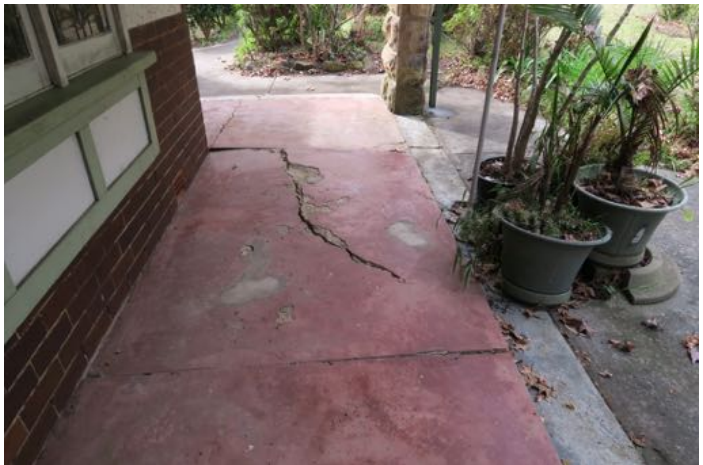
IMG_1504

Cracking present in the slab on the front verandah.

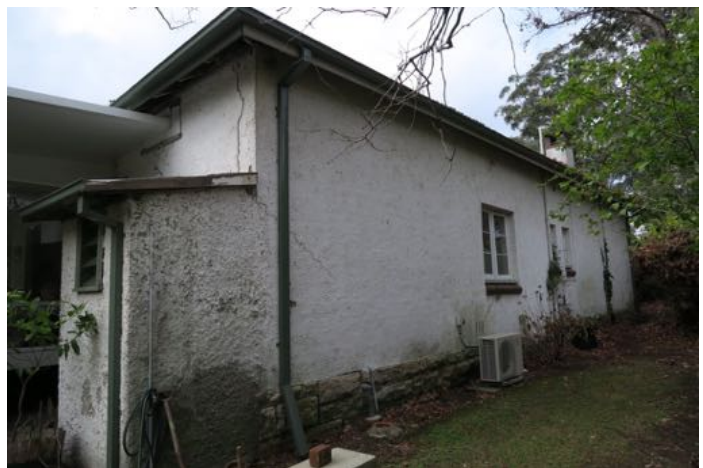
IMG_1506

Cracking at the external toilet and laundry wall junction.

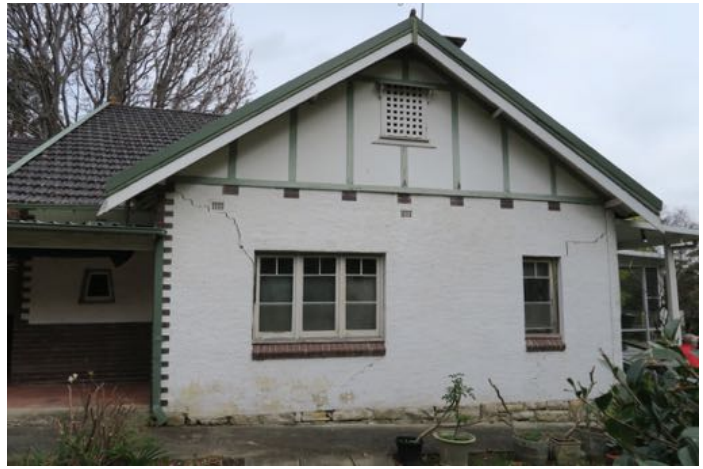
IMG_1514

External view of the eastern wall, with cracking visible on the corners of the windows to the dining room and the kitchen. A down pipe is present on the south east corner of the building adjacent to the dining room window.

4.1. The existing down pipes to the property are to be connected to a suitably designed stormwater system on the property. Ensure that the existing down pipes and gutters have sufficient capacity and are functional to ensure proper operation.

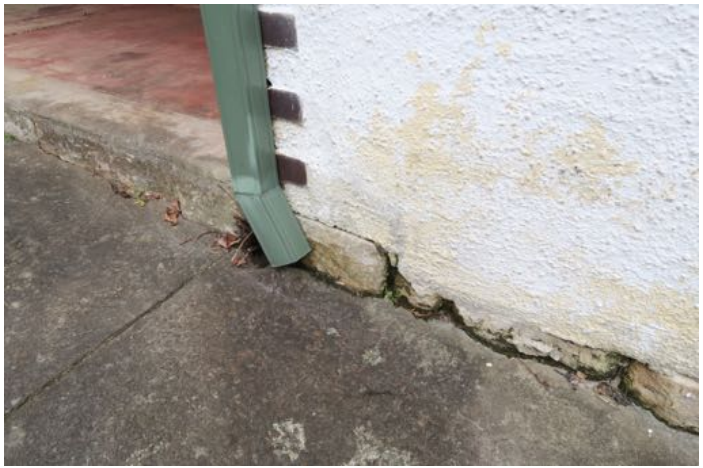
2.11.2.

The down pipes on the property are typically not connected to a stormwater drain, the pipes empty directly to the ground adjacent to the foundations/ walls.

3.2.1. The source of this water is most likely the down pipes on the property which empty directly to the ground below. It is possible that additional water is coming from the ground naturally, but considering the topography of the land that the block is situated on, this source of water should not be causing structural damage.

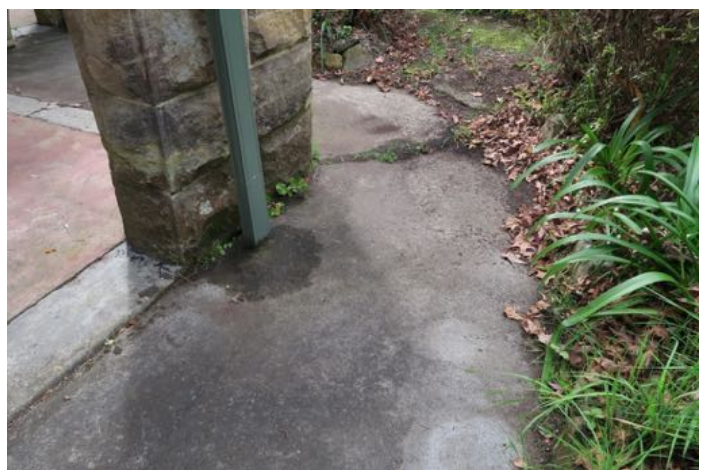
The front sandstone pier on the verandah has a down pipe emptying to the ground adjacent to it.

4.4. The sandstone pier seen in IMG_1521 at the front of the property is to be reconstructed in a plumb manner on adequate footings. The reconstruction of the pier is to be carried out by a appropriately qualified/ experienced stone mason.

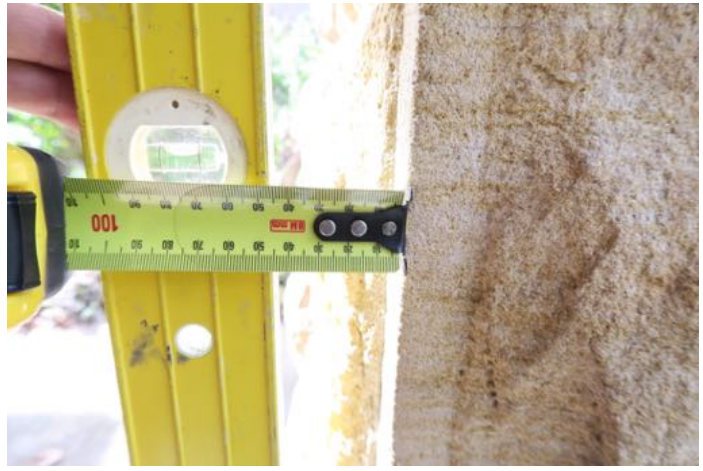
IMG_1523

The sandstone pier is out of plumb by about 45mm over a length of approximately 1200mm.

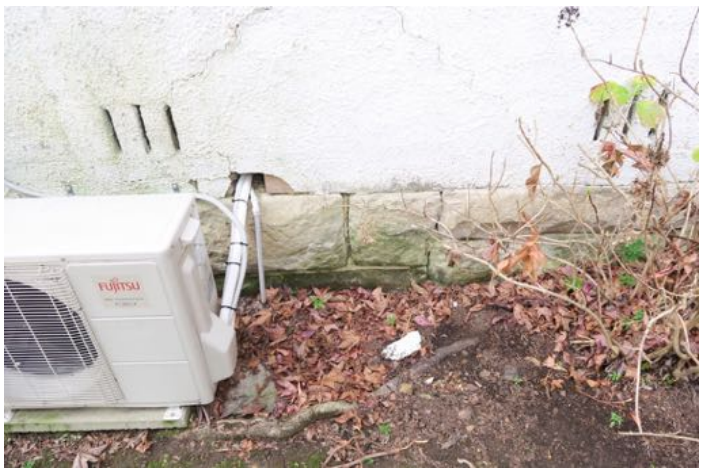
IMG_1527

A tree root is visible at the base of the eastern wall outside the bedroom three wall. The wall in this location has bowed outwards.

3.4. Tree roots are present close to the building west wall and these are to be investigated. For long term stability a root stop wall may be required.

4.7. The roots on the building west side are to be investigated by a suitably qualified arborist to identify if they are invasive in their nature.

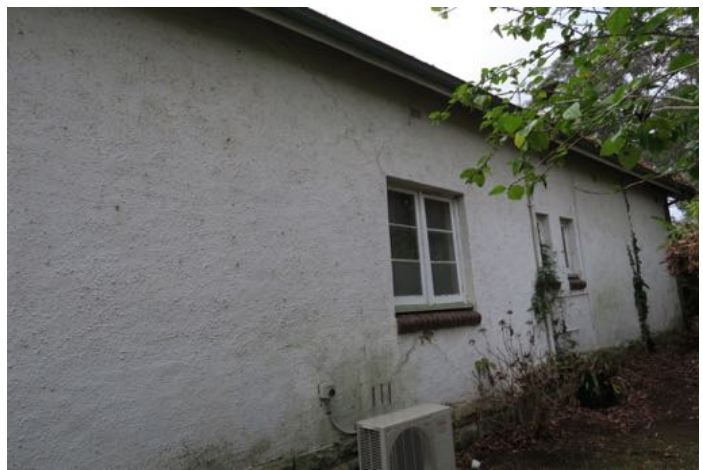
IMG_1507

The wall outside bedroom three shows signs of lateral movement.

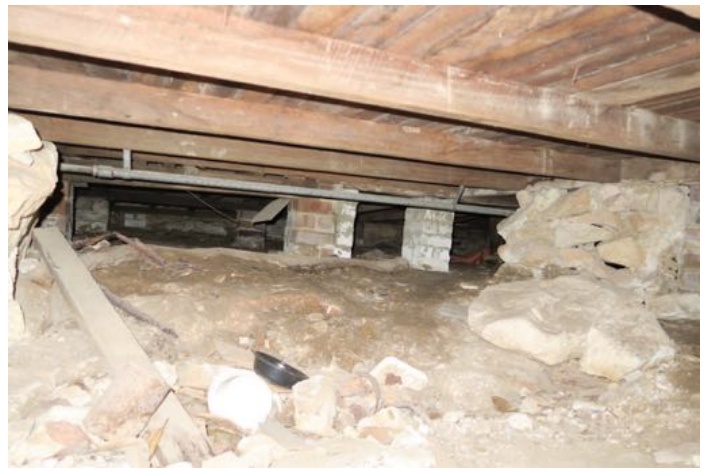
IMG_1535

A view of the underfloor space at the property under the main house.

The condition of the foundations of the brick piers (if there are any) is unknown. There is evidence of water being present in the soil under the house.

4.3. The internal brick piers can be repacked to ensure adequate support for the floor joists is maintained, if required, the joists can be packed out to re-level the floor as required.
