Re: Lindfield K-12 School – Auditorium & Gym Refurbishment Costings

GYMNASIUM & GREENHALGH AUDITORIUM REPORT ON WORKS REQUIRED TO UPGRADE EXISTING FACILITIES & COST ESTIMATES

SCOPES OF WORKS TO ACHIEVE “FIT FOR PURPOSE” FACILITIES FOR USE BY BOTH THE LINDFIELD LEARNING VILLAGE SCHOOL AND THE COMMUNITY 18 APRIL, 2017

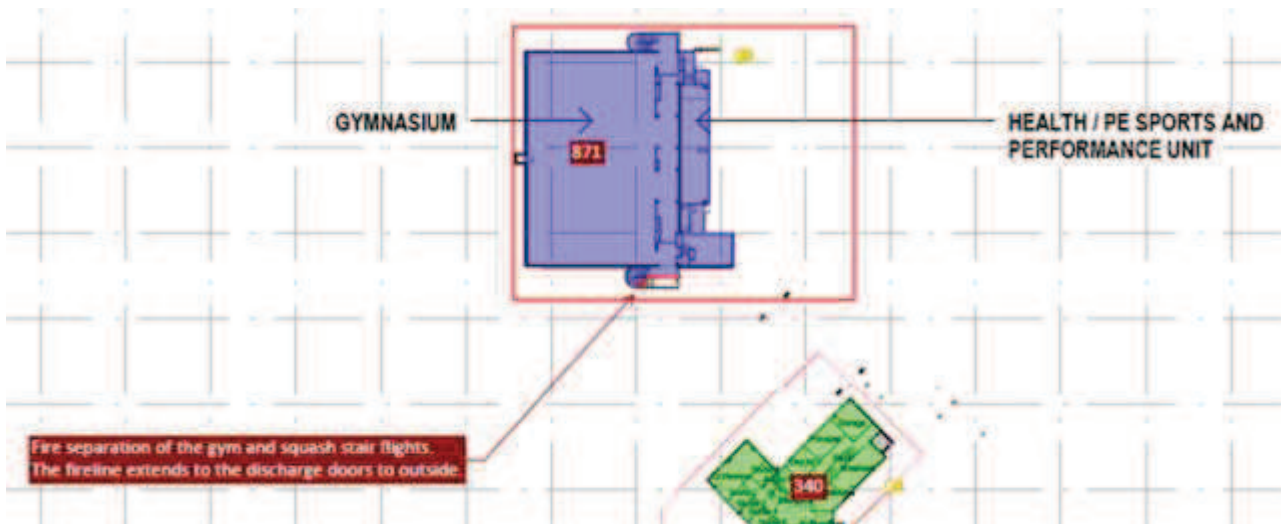
GYMNASIUM – FIRE WALL SEPARATING GYM & SQUASH STAIR FLIGHTS

2.25 As the southern stair connects more than three storeys (links down to the squash court level) a 2hr fire wall & door within the fire stair is required to separate the lower flight down to the squash courts. Sketch below shows new wall & fire door approved in principle by Affinity. Cost estimate allows for this fire wall in the fire stair.

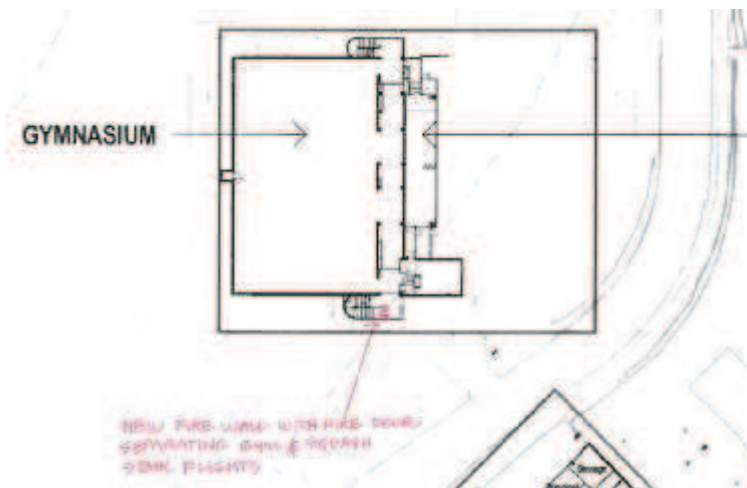
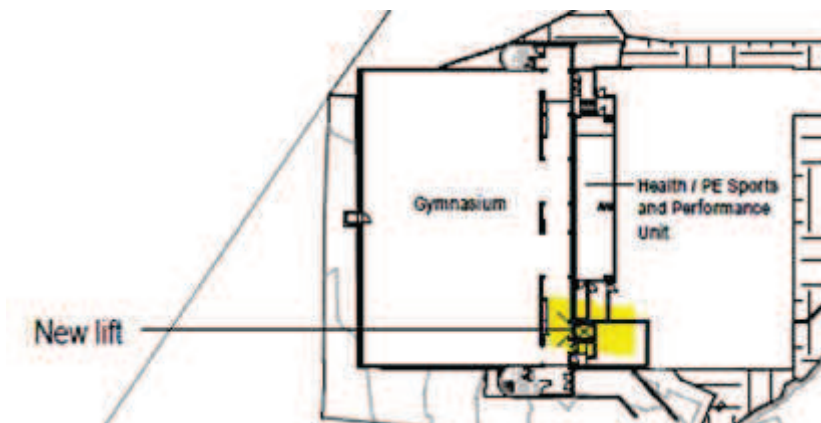
GYMNASIUM – NEW LIFT SHOWN ON LEVEL 4

2.26 Is there a requirement for communications, Wi Fi coverage or audio visual facilities within the gymnasium? Cost estimate includes this.	
2.30 Wheel chair access is currently via a ramp from the access road near the residential apartments on level 4 which gives direct access to the gymnasium floor. A new lift serving levels 4, 5 & 6 will be provided for disabled access from level 4 and this will also provide access to the OOSCH which will be incorporated into the gym – See plan of new lift on level 4 below.

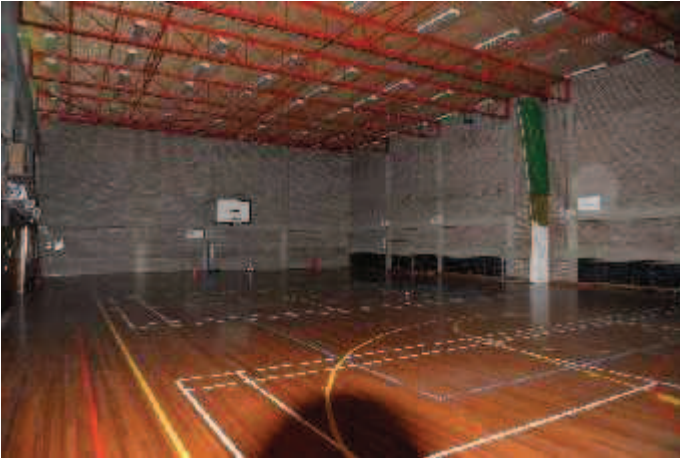
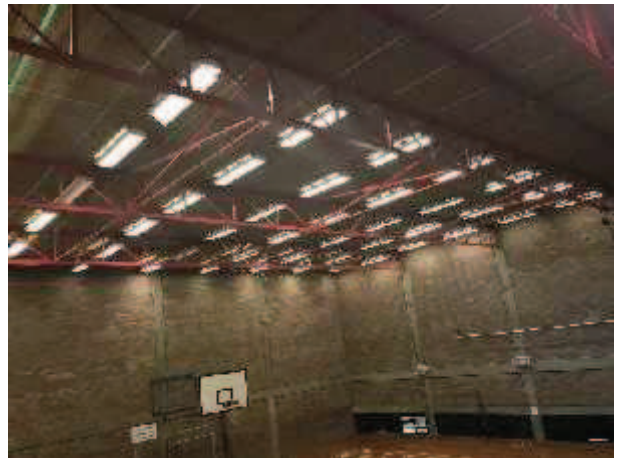
GYMNASIUM - FLOOR, STRAWBOARD CEILING, LIGHTS & DAMAGED METAL LOUVRES

<p>1.3 Check operation and efficiency of all ventilation systems in toilets, showers and change rooms. Upgrade / repair systems as necessary.</p>	
<p>1.4 Repair damaged low level metal ventilation louvres to gymnasium & movement performance spaces.</p>	
<p>1.5 Repair manual controls to operate highlight glass ventilation louvres for cross flow ventilation.</p>	
<p>1.6 Replace non - working lights and damaged light fittings throughout, including the gymnasium, movement performance spaces, circulation and amenities areas.</p>	
<p>1.7 Install additional lights to stair mid landings and upgrade stair tread lighting.</p>	
<p>1.8 Check operation of ceiling mounted “whirlybird” exhaust fans in the dance performance spaces and replace if required.</p>	
<p>2.3 The existing “straw board” ceilings in the gymnasium and dance performance spaces are potential fire hazards and need to be addressed by the fire-engineering strategy where compliance with BCA C1.10 is not achieved. If “strawboard” are non-compliant, they need to be replaced with approved sound absorptive fire resistant panels. Affinity advise to replace strawboard with new acoustic tile ceiling which would not have to be fire rated as the area will have a new sprinkler system. Refer item 2.33. Cost estimate includes replacing strawboard ceiling with sound absorptive fire resistant panels.</p>

2.4 The timber floor structure of the gymnasium (and unprotected steel beams) does not achieve the required fire resistance level for Type A Construction (2hr) and will need to be addressed as part of the fire engineering strategy. Fire engineer (Affinity) advises 3 layers of fyrecheck on steel furring channels fixed to underside of joists & wrapped around steel beams, or intumescent paint on beams. It won't achieve full compliance as floor is not protected from above but can be fire engineered. Fyrecheck protection is allowed for in the cost plan.

2.5 Replace lighting to gymnasium and dance performance spaces with new high bay lighting which is more efficient for these high spaces.	
2.6 Provide "Big Ass" fans to the gymnasium and dance performance spaces to assist with the achievement of the natural ventilation policy required by the Dept of Education.

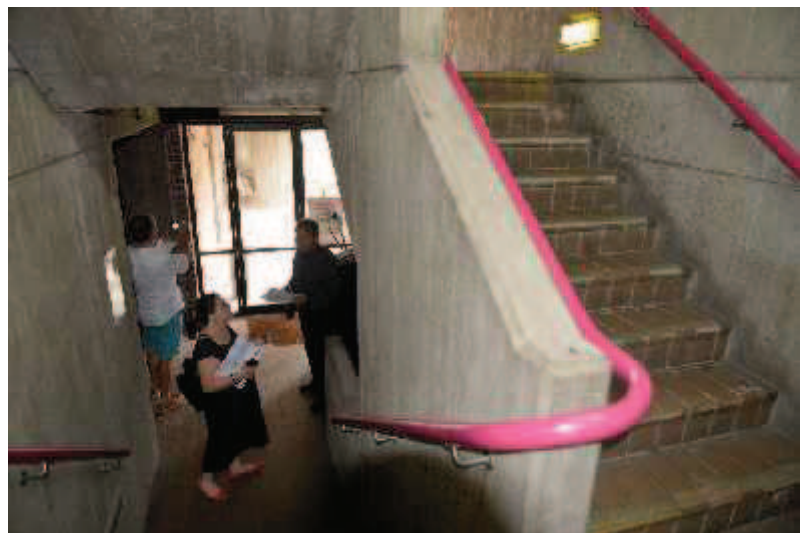
GYMNASIUM - STAIR HANDRAILS

2.14 Handrails to be provided on both sides of stairways with double handrails for primary school aged students (one installed at height above 865mm and other installed at a height between 655mm and 750mm).

2.15 Handrails to be upgraded to provide the required 300mm horizontal extensions top and bottom of all stairs.	
2.16 Tactile indicators required at the top and bottom of all stairs.

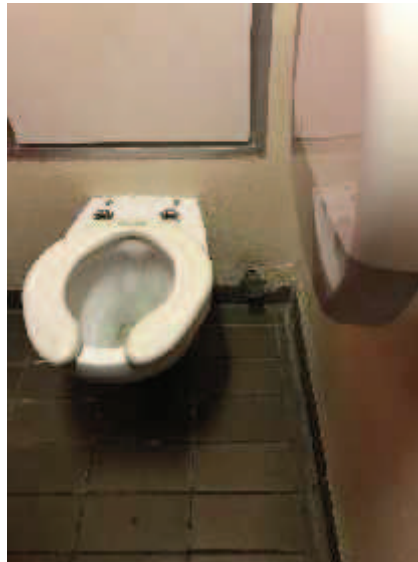
GYMNASIUM TOILET FOOT PUMP

1.16 Check operation of all taps, hand driers, shower roses and toilet paper holders and repair/replace damaged ones as required.	
2.11 Replace outdated foot operated cisterns with modern button in cistern or in wall button. This will also involve alterations to the central water tank supply.

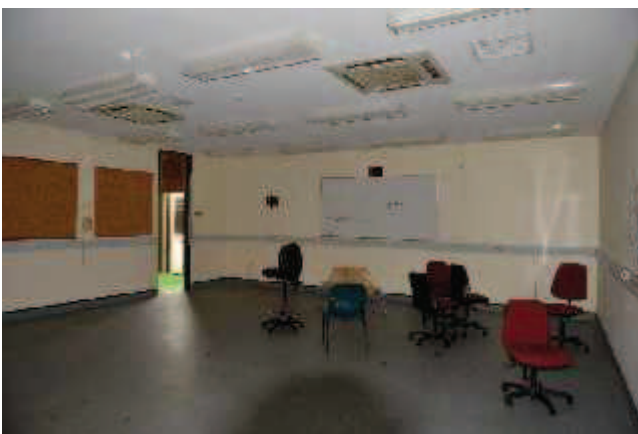
GYMNASIUM – INTERNAL SEMINAR ROOM

1.20 Check operation of ventilation/air conditioning system in internal seminar room on level 6	
1.21 New AC to level 6 office areas.	
1.22 Polish gymnasium and dance performance floors to ensure serviceability.

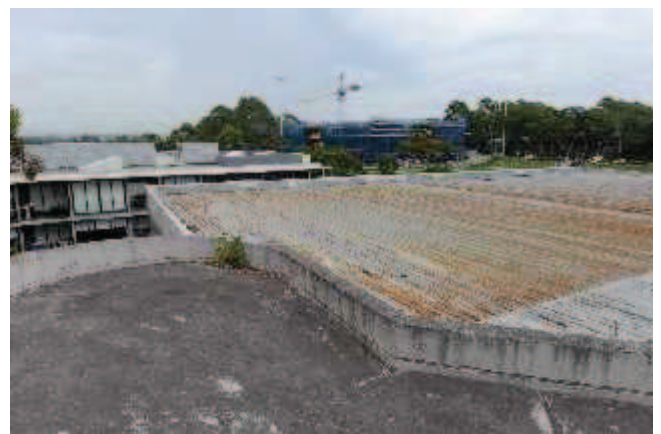
GYMNASIUM – RUSTED ROOF

2.20 Install security system with access control and CCTV	
2.21 Install external lighting to suit current codes.	
2.22 Replace rusted, deteriorated roof sheeting and parapet flashings

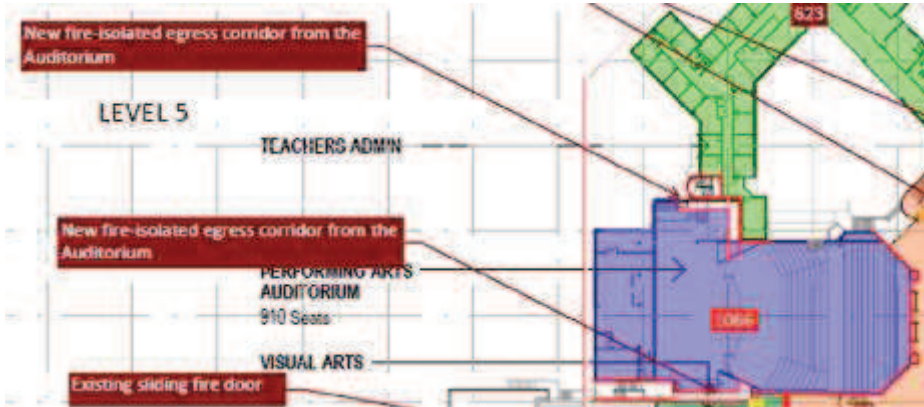
AUDITORIUM LEVEL 5 - FIRE ISOLATED CORRIDORS – 1 NEW & 1 UPGRADED TO MAKE FIRE ISOLATED

3.6 A fire engineer must check the various paths of egress from the auditorium, their widths and travel distances to ensure that there is adequate, clear egress from the auditorium. Some egress paths appear to travel through non-fire rated corridors, some exit into the central courtyard and other routes exit through other parts of the building. Fire exit doors and some egress corridors are narrow and should be checked for egress width. Affinity Fire Engineering advise 2 fire isolated corridors required for egress from level 5 (see attached plan) - one new non-fire rated corridor & the existing corridor modified to make it fire isolated (additional fire doors). Included in cost estimate. The mid-level egress into the courtyard and into the internal corridor system remains as existing but with upgrade of doors. Level 4 plan shows egress through existing doors into courtyard & into internal corridor system. BCA Logic advise aggregate width of egress required is 9.5m (email dated 13.3.17). Egress width appears to total 10m, assuming double doors 1.4m wide count as 1m.

4.6 As mentioned in item 3.6 of this report, undertake any building works required by the fire engineer to address any fire egress issues. See drawings below of fire- isolated corridors. Included in cost estimate.

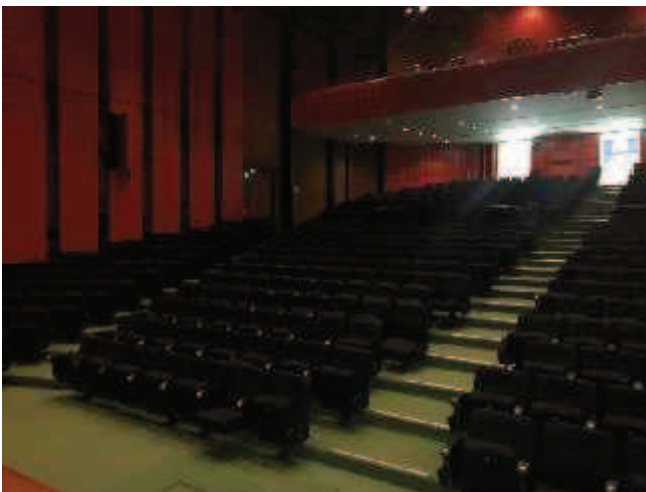
AUDITORIUM – SEATING, WALL PANELLING, STAGE

3.7 In their High- Level BCA Overview Report, dated 6 April, 2016, BCA Logic identified potential fire hazard properties of the timber wall cladding in the auditorium which will need to be addressed by the fire-engineering strategy where compliance with BCA c1.10 is not achieved. Fire rating of wall cladding to be checked.

4.7 As mentioned in item 3.7 of this report, replace timber wall cladding if required by the fire engineer. As Affinity Fire Engineering has advised that the interior of the auditorium has to be sprinkler protected, the wall panels must achieve a 1,2 or 3 group number (which the existing wall cladding may satisfy) & thus may not require replacement. Cost estimate allows for replacement of wall cladding.

4.8 Replace all seating with new and this may necessitate replacing all the carpet with new due to exposed fixing holes, etc. The seating does not have to be replaced unless for cosmetic reasons, however, if it is replaced, the distances between seat rows will have to be adjusted to achieve “Entertainment Venue” classification. This will require modification of the stepped floor & replacement of the carpet which would be extremely expensive. Cost estimate does not allow to replace the seats or carpet. PRG decision made not to replace seating or carpet.

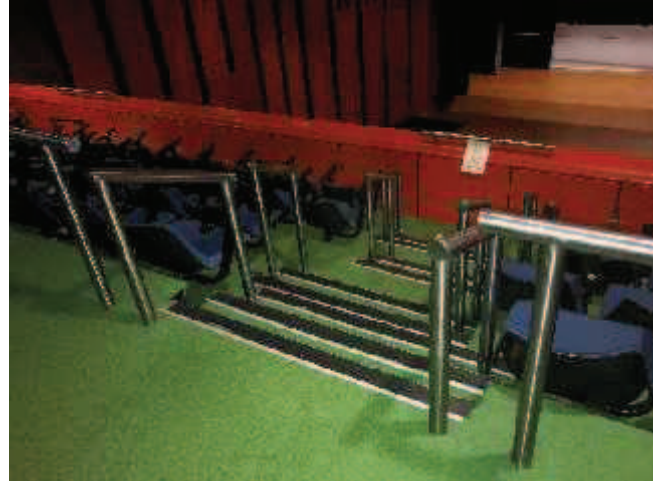
AUDITORIUM – LOW HEIGHT BALUSTRADE, HANDRAILS

3.14 Balustrade in front of mezzanine tiered seating to be increased in height to no less than 1m above the finished floor finish.	
3.15 If stage performers require back of house amenities, check operation of all toilet pans, taps, basins, hand driers, shower roses, toilet paper holders and repair/replace damaged ones as required.

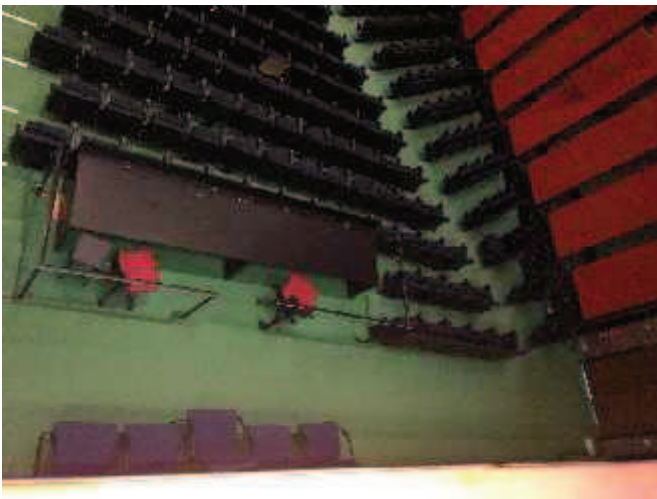
AUDITORIUM – WHEEL CHAIR SEATING

3.20 Upgrade the area for wheel chair spectators to BCA requirements. This may involve additional handrails, etc.	
3.21 It is possible to restrict access to various spaces if they are not required to be used, in order to avoid any necessary renovations.

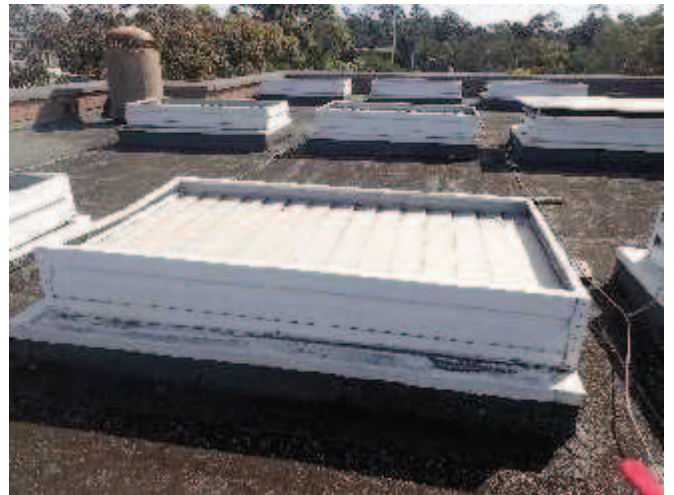
AUDITORIUM – ROOF MOUNTED SMOKE EXHAUST VENTS

3.5 There are about a dozen existing roof mounted smoke exhaust ventilation units that do not work as their hydraulic lines are corroded and the ventilation louvres appear seized and inoperable. It is critical that they open in the event of a fire to evacuate the smoke and they must be repaired or replaced to ensure the safety of the occupants of the auditorium. Ausmech test says smoke vents working, but there will be a large cost if they do not.

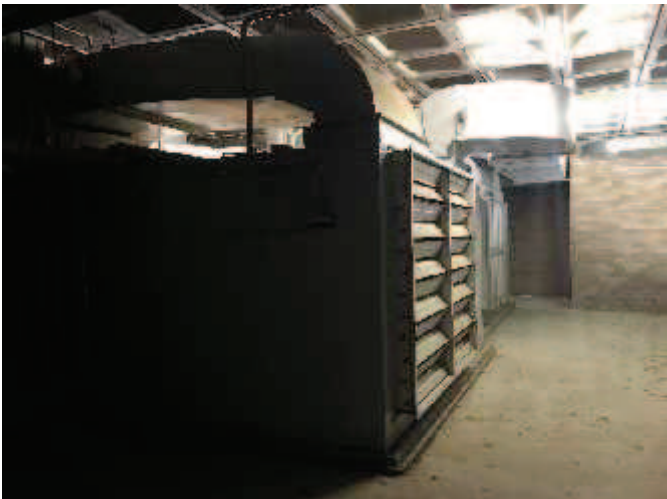
AUDITORIUM – PLANT AIR HANDLING UNITS AND DUCTWORK

3.16 An air conditioning contractor needs to make an assessment of the condition and efficiency of the air conditioning plant and ductwork that serves the auditorium. Preliminary advice by the Erbas mechanical engineer is that all the air handling units and chilled water piping, etc in the plant room have passed their recommended service life and need replacing. Although the existing plant equipment still operates, it would not pass compliancy, thus replacement of ageing HVAC equipment including chillers, re-lagging to ductwork/pipework, new air handling systems is recommended by Erbas. Included in cost estimate.
