# HERITAGE ASSESSMENT REPORT **DRAFT**

“Wainberg House”

33 Young Street, Wahroonga

for  
**Ku-ring-gai Municipal Council**

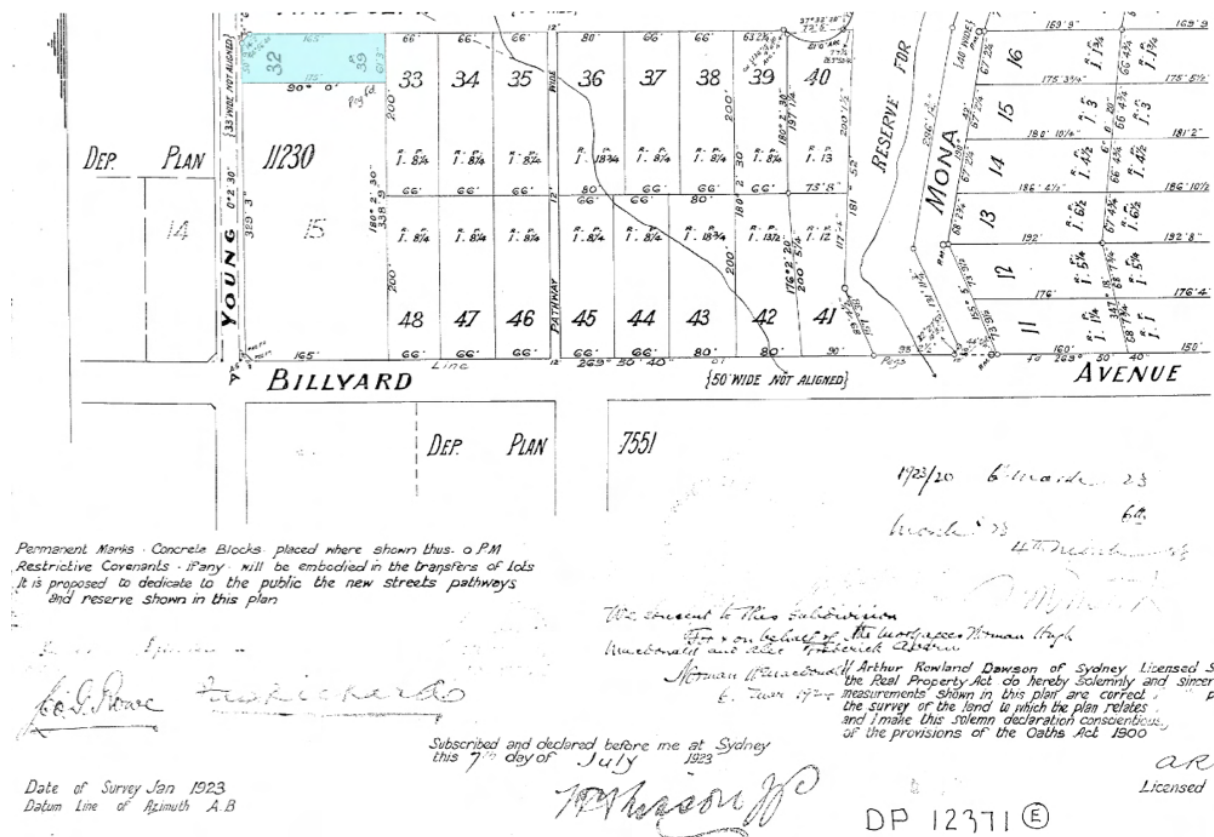
Figure 4.1: The 1923 "Brundah Park Estate" DP 12371 with the subject lot (Lot 32) on the corner of Young & Randolph Streets coloured blue (Courtesy Ku-ring-gai Council with Robertson & Hindmarsh overlay 2021)

This land was part of an early 2000-acre (809 ha) Crown grant to John Terry Hughes in 1842. A substantial residential subdivision of land around the subject site occurred in 1922 under DP 11230, into large acre lots. In September 1923, the NSW Realty Co Limited acquired lots 16 to 33 of this estate, totalling over 17 acres (6.9 ha) in size. NSW Realty Co Limited re-subdivided the land under the current deposited plan, DP 12371, known as the "Brundah Park Estate." The subject site officially came into being at this point, as lot 32 DP 12371, at a size of 39 perches (986.42m<sup>2</sup>) (see **Figure 4.1**).

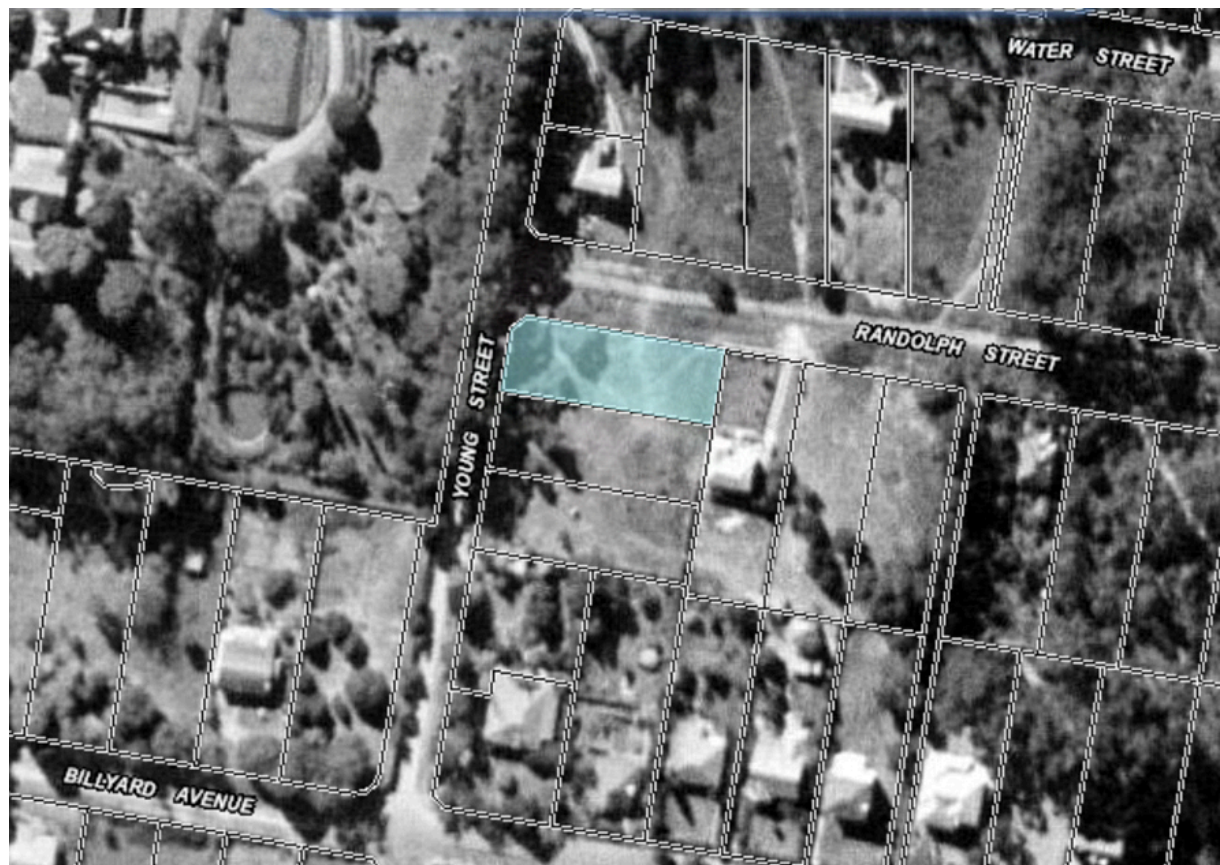
Figure 4.2: The site of the Wainberg House (coloured blue) in 1943 with the 2020 subdivision lot boundaries (Source: SixMaps with Robertson & Hindmarsh overlay 2021)

The 1948 aerial photograph (**Figure 4.2**) shows the vacant site and the sparse development in the vicinity of the site. In July 1949, the lot was transferred to the said Michael Wainberg of Annandale, Dyer, as sole proprietor.

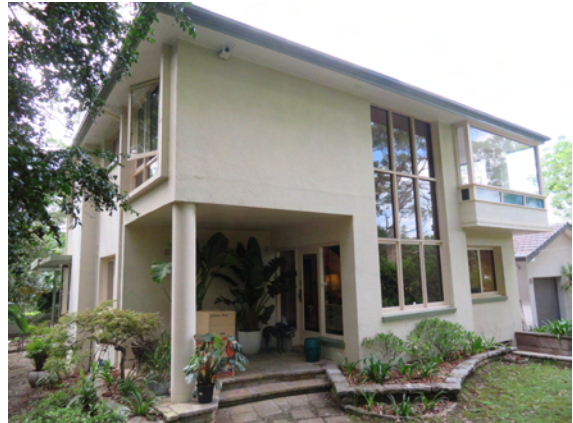
Figure 5.2 Entrance porch. Note rendered window architrave at left & stair hall window on right (Photo: Robertson & Hindmarsh P/L)

The large windows of Bedroom 4 on the First Floor have a much lower sill height than the other First Floor windows and the window is further emphasised and given importance by the protruding rendered "architrave" around the exterior of the window (**Figures 5.2 & 5.11**). The double-height window wall illuminating the Entry Foyer and Stair Hall is the major feature of the west façade (**Figures 5.1 to 5.4**). The original First Floor verandah has been enclosed to form a Living Room and its mullion-less and frameless Cowdroy sliding glass sashes are a prominent feature of the front façade. There is a low rendered wall forming what was probably the base of the original verandah balustrade and there would appear to be a small drainage hole at the east end of the verandah, indicating that the Living Room was intended to be an open verandah (**Figures 5.2 to 5.5**).

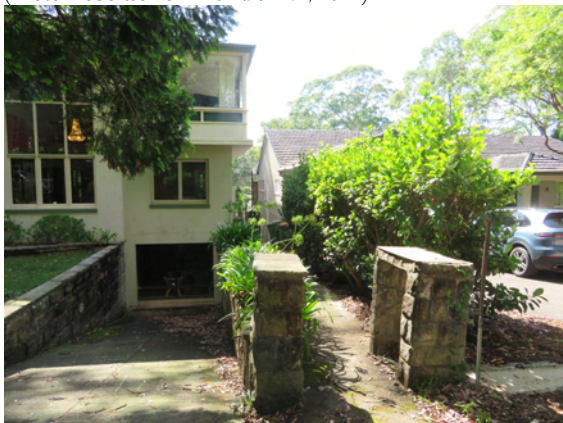
Figure 5.3 Drive down to original garage. Note sandstone gas meter enclosure on right (Photo: Robertson & Hindmarsh P/L, 2021)

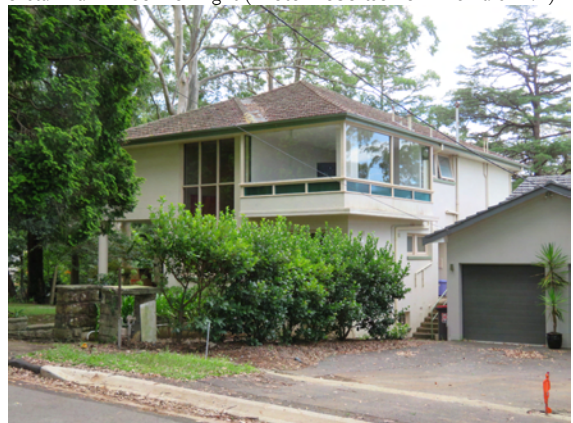
Figure 5.4 View of house from south-west in Young Street  
(Photo: Robertson & Hindmarsh P/L, 2021)

The site has no boundary fencing along the two street frontages but has sandstone gate pillars at the driveway and a sandstone box flanking the tradesman's entrance that contains the gas meter (**Figure 5.4**). In lieu of a fence, the two street boundaries are defined by sandstone flagging mounted on edge used as a haphazard garden bed edging.

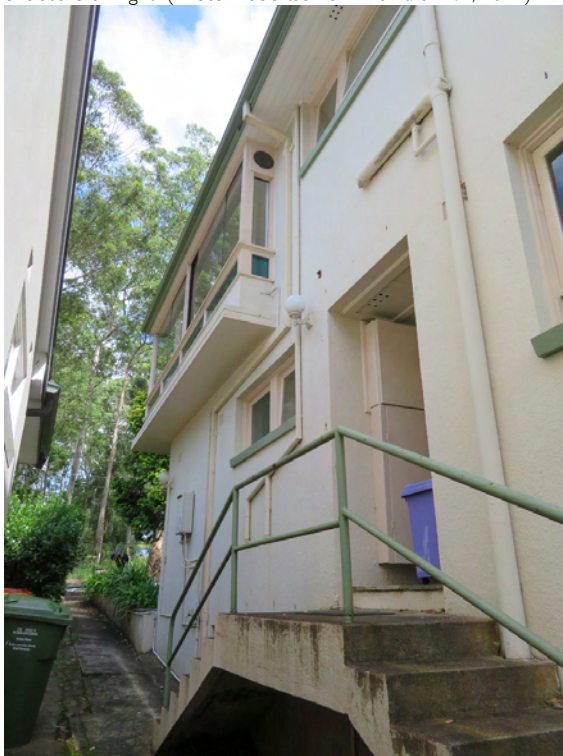
Figure 5.5 View of service entry to house on south side  
(Photo: Robertson & Hindmarsh P/L, 2021)

There is a side yard along the north side of the house with a terrace outside the Lounge Room windows. Along the south side of the house is a concrete path leading to a set of stairs up to the tradesman's entry porch. From the porch level the concrete stairs descend to the continuation of the concrete side path leading down to the lower level of the rear yard (**Figures 5.5 & 5.6**).

One original exterior wall light fitting remains above the landing of the service entrance on the south side of the house (**Figure 5.5**).

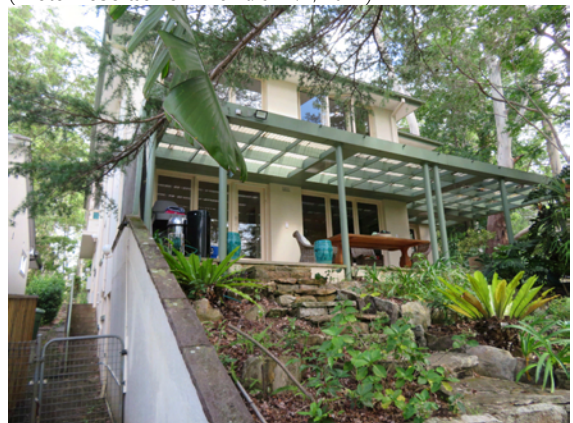
Figure 5.6 View of house from south-east. Note the sloping retaining wall retaining slope from terrace  
(Photo: Robertson & Hindmarsh P/L, 2021)

At the rear of the house there is a sandstone terrace accessed from the Kitchen and Lounge Room. The terrace is paved in regular sandstone paving and there is a steel post-supported clear fibreglass roof over the terrace. Whilst the current terrace is not original it would appear that some form of paving existed outside the Kitchen & Lounge Room doors. The site slopes steeply down from the terrace to the rear lawn and swimming pool and this slope would appear to be original as it is retained along its south edge by a rendered, painted retaining wall that is continuous with the lower masonry balustrade at the south end of the terrace which is, in turn, continuous with the south wall of the house. The steep slope is negotiated by a couple of informal paths and sets of garden steps of unequal height (**Figure 5.6**).

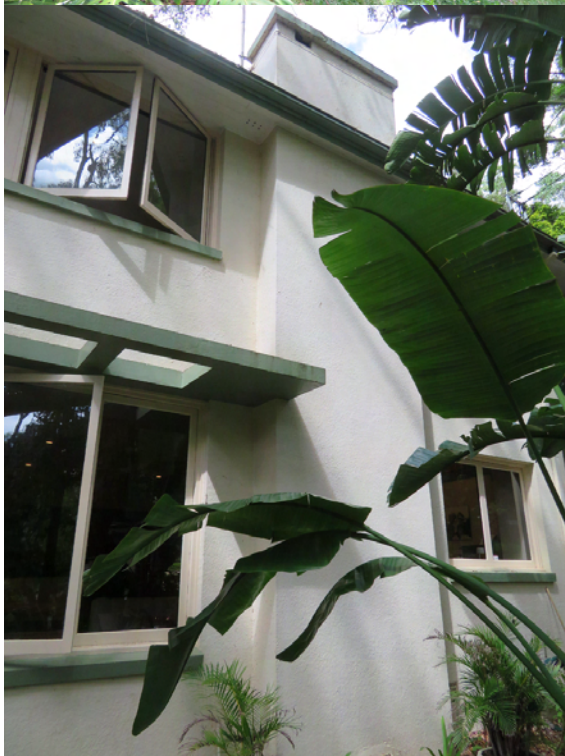
Figure 5.10 North side of house with Lounge window on left  
 (Photo: Robertson & Hindmarsh P/L, 2021)

The windows are an important design feature of the house and they comprise large timber casement-hung sashes with no central meeting mullion. This allows the windows to be thrown open to create large openings that connect the interior to the exterior. The casement sashes are hung on Whitco friction stays and the sashes are held closed by casement window catches. The windows in the former Basement Garage & WC are new replacement aluminium windows and the windows of the First Floor Living Room are frameless glass sliding sashes on steel guide tracks.

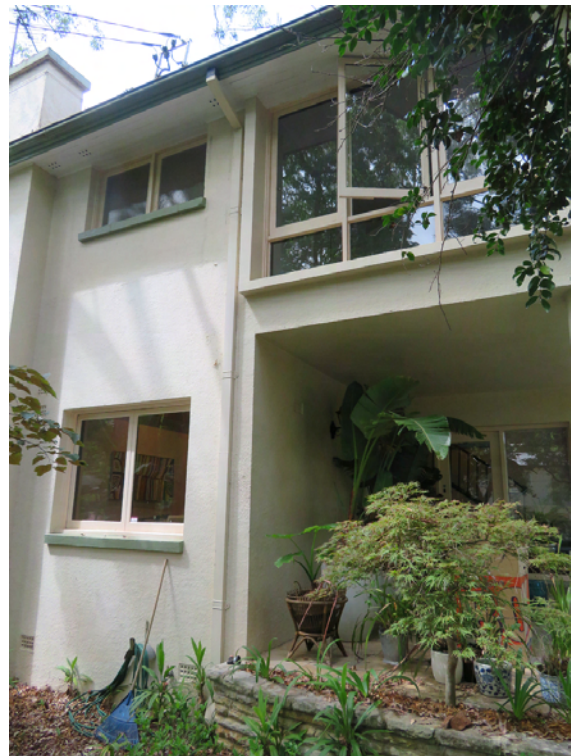
Figure 5.11 North side of house with Office window below Bathroom window. Large Bedroom 4 window on the right above the Entrance Porch (Photo: Robertson & Hindmarsh P/L, 2021)

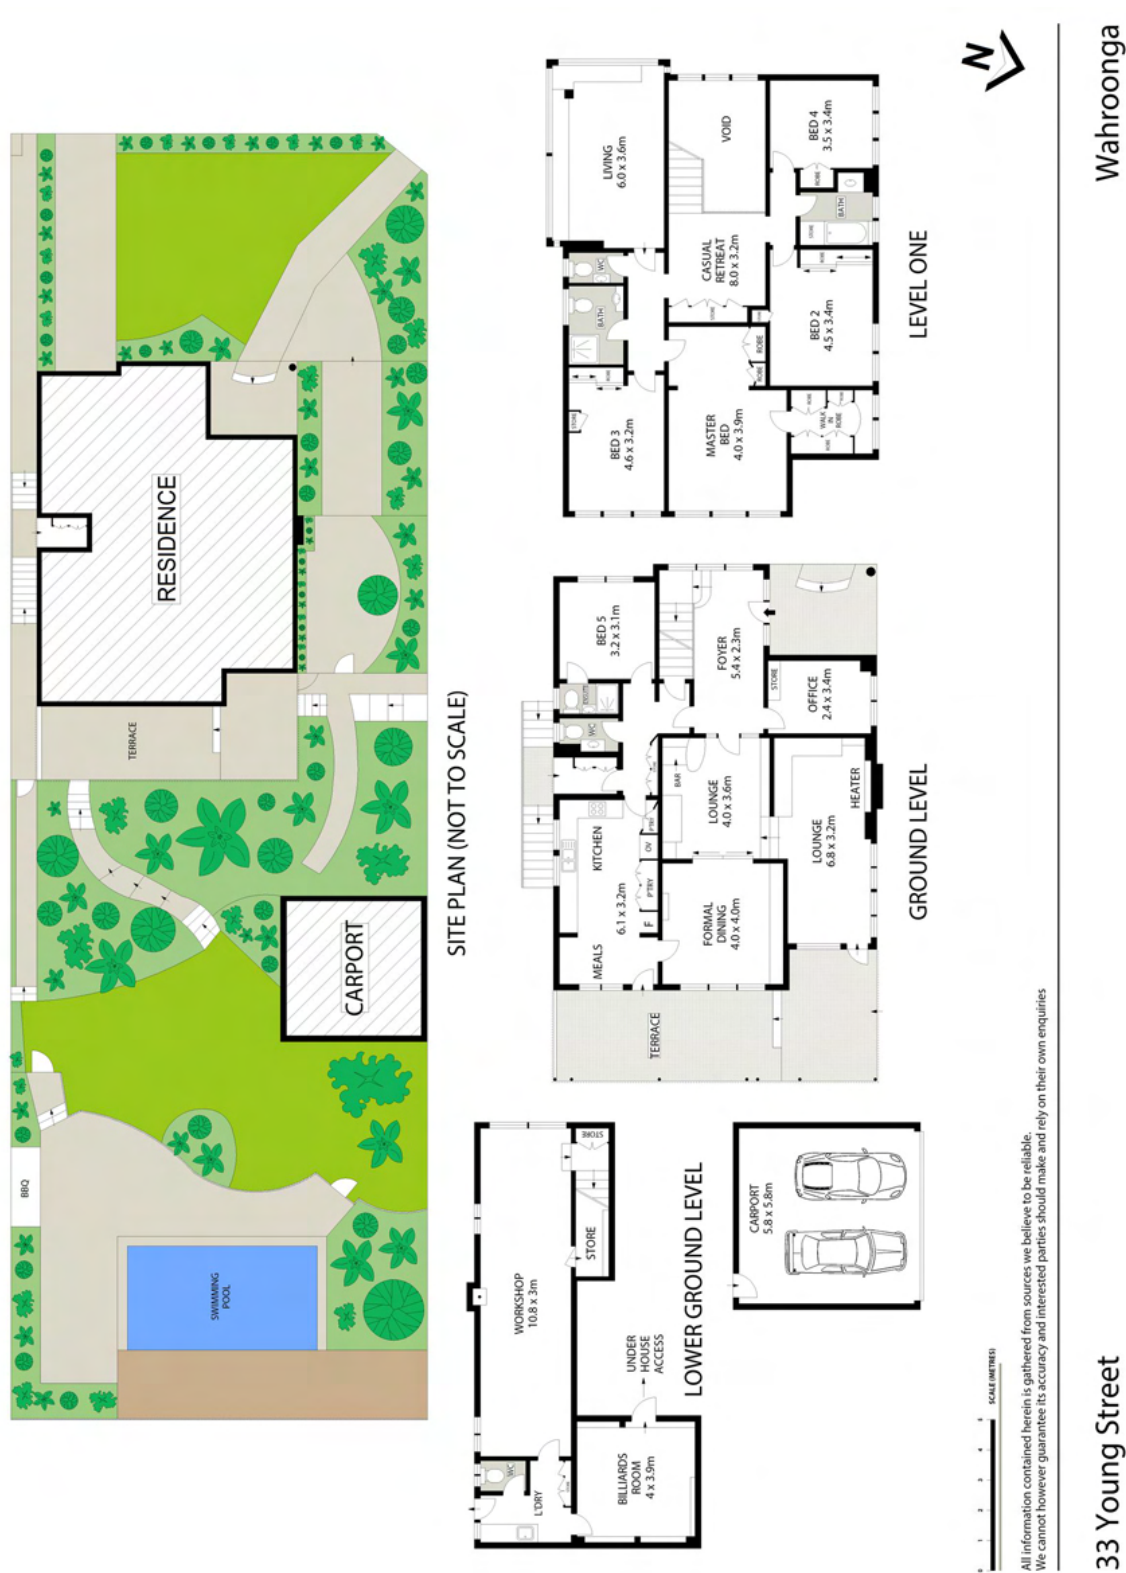
Figure 5.12: Floor Plans, 33 Young Street, Wahroonga, 2020 (Source: Real Estate.com)

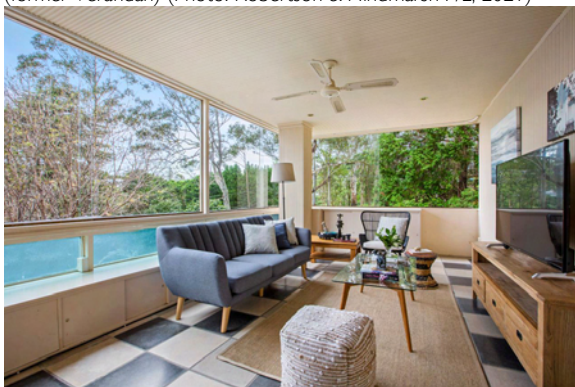
At the west end of the hall is the enclosed former Verandah (**Figures 5.64-5.69**). The floor is paved with square tiles; black and two shades of cream that is one step lower than the general floor level of the First Floor (**Figures**

**5.66-5.69).** There appears to be the remnant of a drainage outlet at the east end of the verandah (as discerned from outside). The north and east walls and the ceiling of the room are sheeted with timber sheeting faced with fluted timber beads (**Figures 5.64-5.67**). The south-west corner of the roof is supported on a column that is also sheeted in the same fluted timberwork. This timberwork is painted. The west and south walls are enclosed with frameless sliding glass windows mounted above fixed panes of blue glass which are, in turn, located above built-in cupboards with sliding timber doors (**Figures 5.64 & 5.67**). The cupboards at the west end of the room are taller and conceal the blue glass panels (**Figures 5.64 & 5.65**).

Figure 5.64 First Floor Living Room (enclosed former Verandah) (Photo: 2020 sale photograph from Real Estate.com)

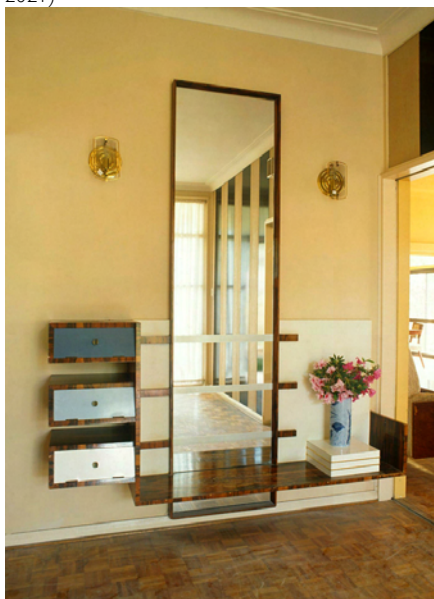
Figure 6.21: Moses House, Hall stand made by Paul Kafka. House refurbished by architect Henry Kurzer, 1959. Photo by Louise Lister, 1991 (Source: Sydney Living Museums accessed 12 January 2021)

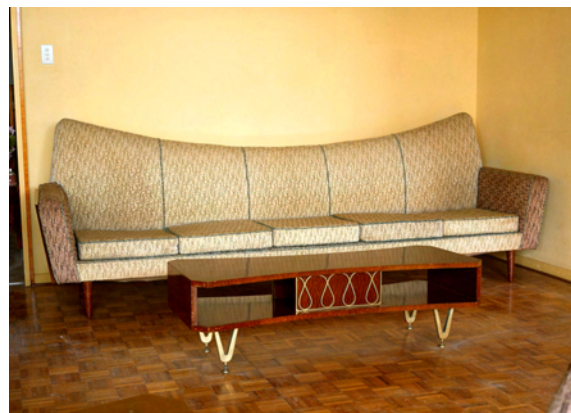
Figure 6.22: Moses House, Couch made by Paul Kafka. Photo by Louise Lister, 1991 (Source: Sydney Living Museums accessed 12 January 2021)

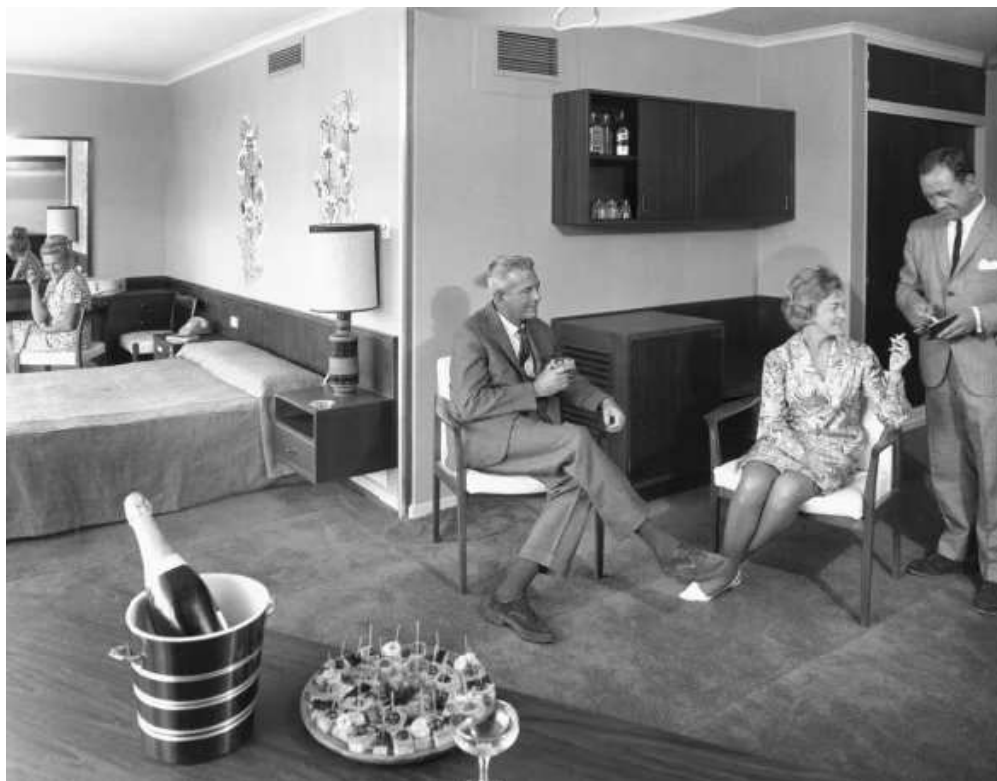
Figure 6.23: Max Dupain & Associates image of Kafka cabinetry in Hugo Stossel-designed Travelodge Wynyard room, nd  
(Source: Shelley Gare, "Sydney's Forgotten Mid-century Modernists", *Australian Financial Review*, 31 October 2020)
