Our Ref: 17007.SI170703a 69 Kissing Point Rd- Structural Inspection

69 KISSING POINT ROAD, TURRAMURRA: SITE INSPECTION 7TH JULY 2017

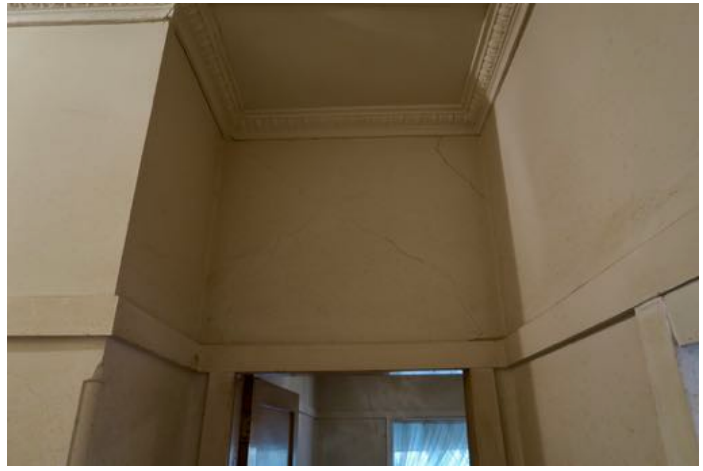
Entry into the bedroom from the hallway.

Cracking seen from the internal wall as seen in IMG_1469

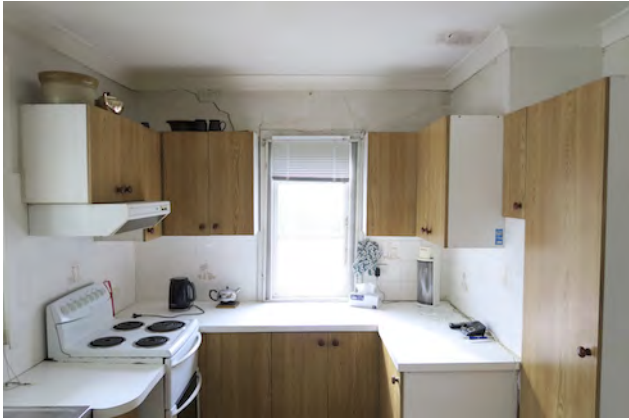
IMG_1449
Cracking is visible on the interior skin of brick work, above the exterior window.

These cracks are to be structurally stitched with a helical reinforcement system such as Helifix or similar, to manufacturers specification. This should occur minimum six months after the down pipes have been connected.

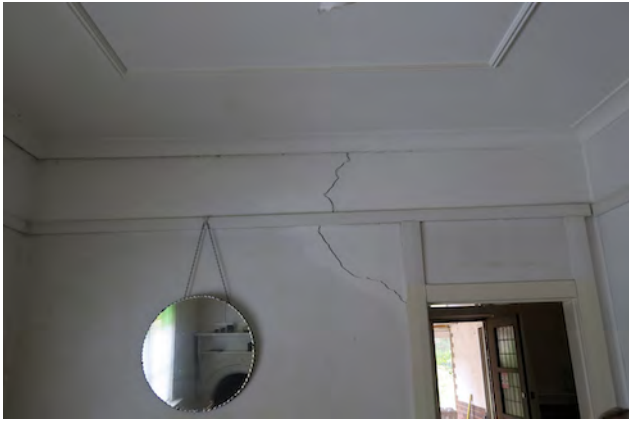
IMG_1452

Cracking is present on the internal southern wall.

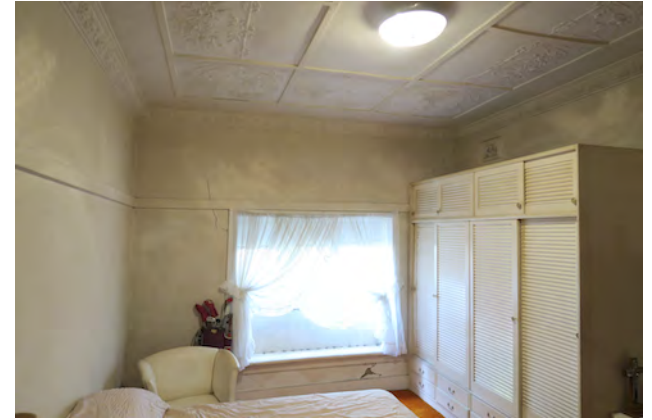
IMG_1470

Cracking is present on the upper corners of the window and below the window, similar to the main bedroom.

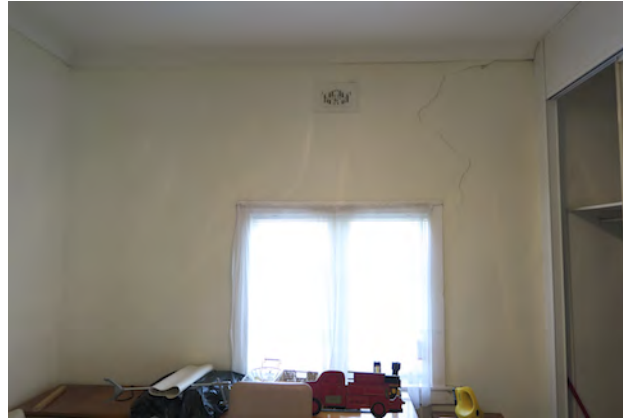
IMG_1478
Cracking present in the western wall.
